EXECUTIVE SUMMARY
July 15, 2002 Chemical Agent Exposure at
Tooele Chemical Disposal Facility (TOCDF)

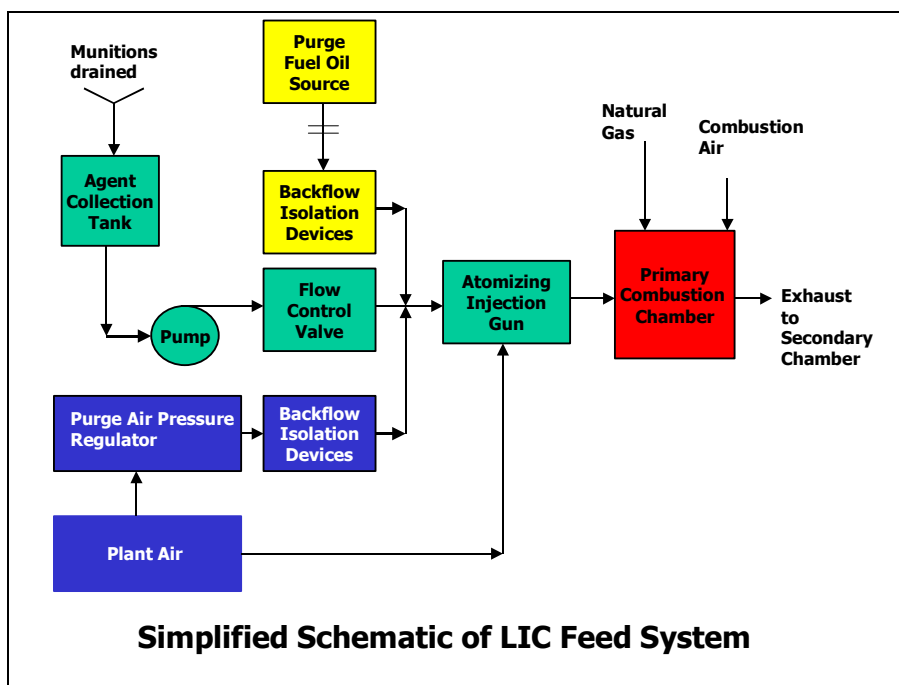
A pump draws agent from the first collection tank and injects it into the primary combustion chamber through an atomizing nozzle. After emptying the first tank, the pump is stopped, the agent remaining in the agent line is purged with air, and the pump is realigned to draw from the second collection tank. Air purging is controlled by a pressure regulator designed solely for use with air. To prevent backflow of agent into the air pressure regulator, backflow isolation devices (a series of check valves and a block valve) are contained in the air line. A fuel oil line is also attached to the agent line to allow flushing of residual agent in the system at the end of an agent-burning operation and prior to a controlled shutdown. During normal operation, in order to prevent agent backflow past the backflow isolation devices in the fuel oil line (identical to those in the air purge line) the fuel oil line is disconnected from the agent line by removing a flexible section of the line and attaching flanges (plates) to close the ends. The agent purge and flushing (air purge followed by fuel oil purge followed by air purge) cycles are automatically controlled through the Program Logic Control system. See simplified schematic below.

On January 16, 2002, high levels of agent GB were detected in the LIC 1 Primary Room. Control room operators, using remote cameras, identified the source of agent leakage when agent GB was observed dripping from the newly installed modified air pressure regulator assembly, indicating that agent had migrated beyond established engineering ("agent expected" (AE)) boundaries in the air purge line. Agent feed to LIC 1 was stopped. Through engineering observations and analysis, it was determined that the check valves and block valve in the backflow isolation devices were "frozen" in the open position and could not be repaired. A Temporary Change was issued to fabricate and install a new set of valves to replace the leaking check valves and block valve. Full PPE was used and proper planning and precautions were taken. Although entries were made in the shift logs of January 16 and 17 describing the event
